Re: Notice of Violation
Compliance Evaluation Inspection
MND985767482

On April 28, 2015, representatives of the U.S. Environmental Protection Agency and Anoka County, Minnesota, inspected the Eco Finishing Company facility located in Fridley, Minnesota (EFC). As a large quantity generator of hazardous waste, Eco is subject to the Resource Conservation and Recovery Act, 42 U.S.C. § 6901 et seq. (RCRA). The purpose of the inspection was to evaluate Eco's compliance with certain provisions of RCRA and its implementing regulations related to the generation, treatment and storage of hazardous waste. A copy of the inspection report is enclosed for your reference.

Purpose of Inspection: This inspection was an evaluation of ECO Finishing Company, Incorporated's (ECO Finishing) compliance with hazardous waste, used oil, and universal waste regulations found at the Minnesota Hazardous Waste Rules (Minn. R.) and the Code of Federal Regulations (CFR). I performed the inspection with two inspectors from Anoka County. The inspection was an EPA lead Resource Conservation and Recovery Act (RCRA) compliance evaluation inspection (CEI). The site notified as large quantity generator (LQG). The last

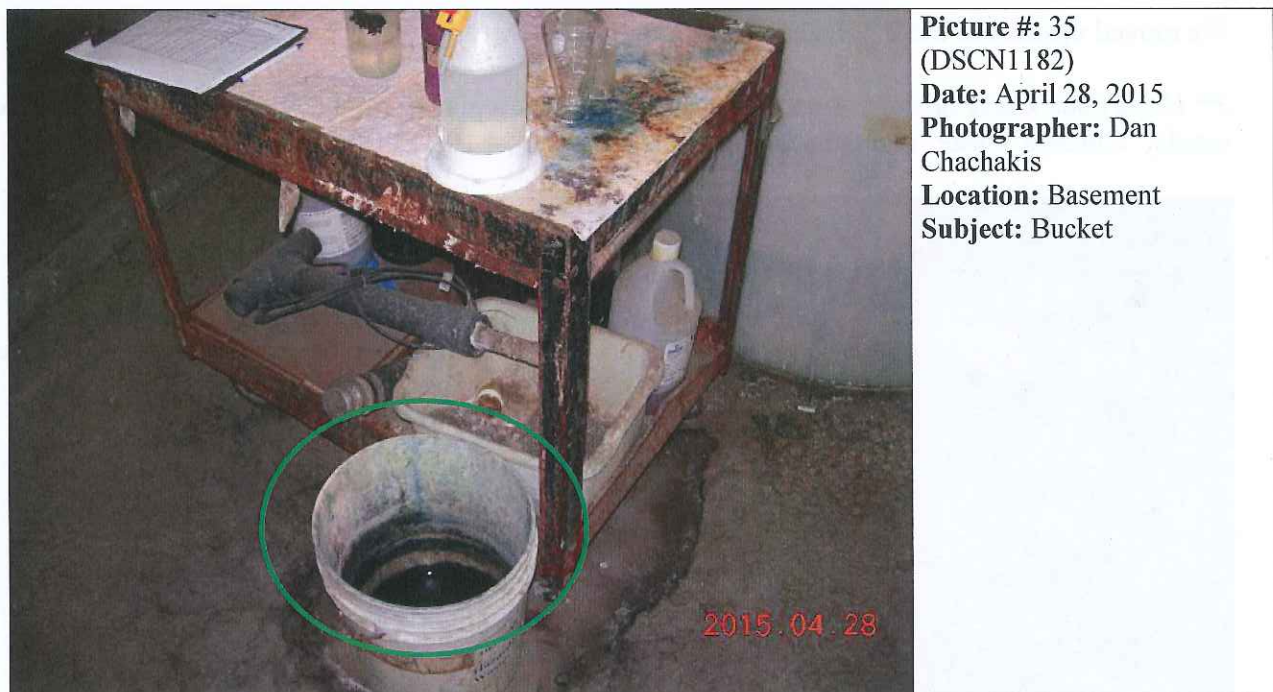
Picture #: 35
(DSCN1182)
Date: April 28, 2015
Photographer: Dan Chachakis
Location: Basement
Subject: Bucket

I observed, and took a picture of, a container (Picture 35). I observed that this container contained less than two inches of material, was not closed, and was apparently not in position to capture waste.

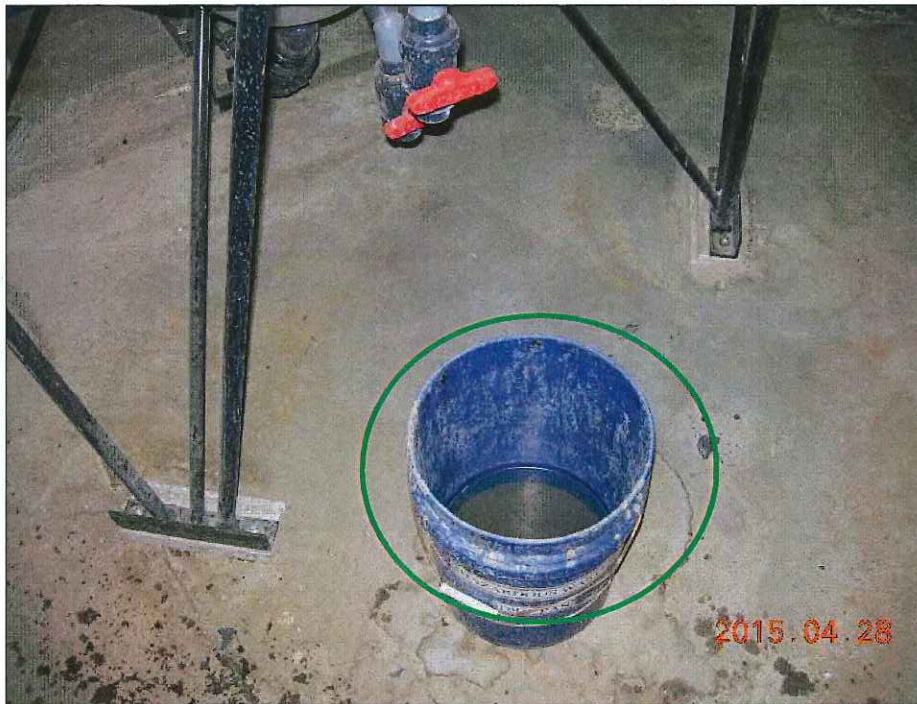
Picture #: 36
(DSCN1183)
Date: April 28, 2015
Photographer: Dan Chachakis
Location: Basement
Subject: Bucket

I observed, and took a picture of, a container that was not in use (Picture 35) and not closed. This was near the cyanide destruct clarifier tank.

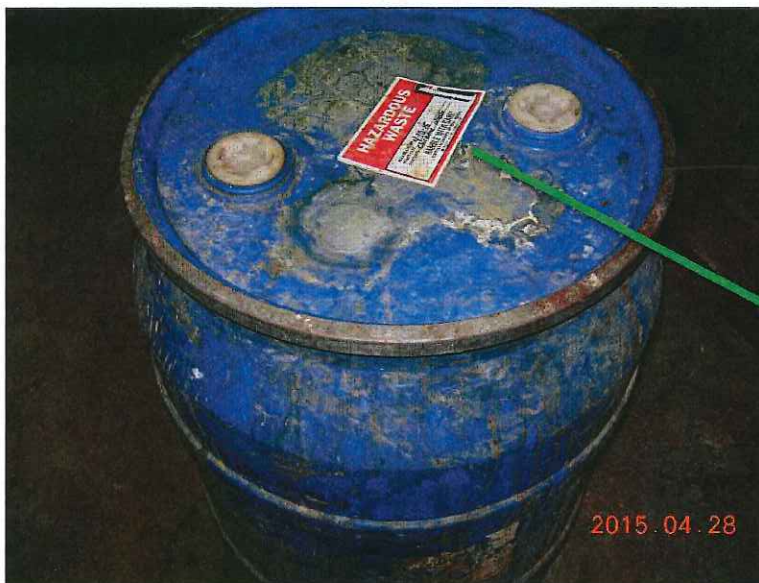
Picture #: 37
(DSCN1184)
Date: April 28, 2015
Photographer: Dan Chachakis
Location: 2nd Hazardous Waste Storage Area
Subject: Container

2nd Hazardous Waste Storage Area: I observed, and took a picture of, a container marked with the words, "Chrome Waste" and the accumulation start date "4/10/15" (Picture 37).

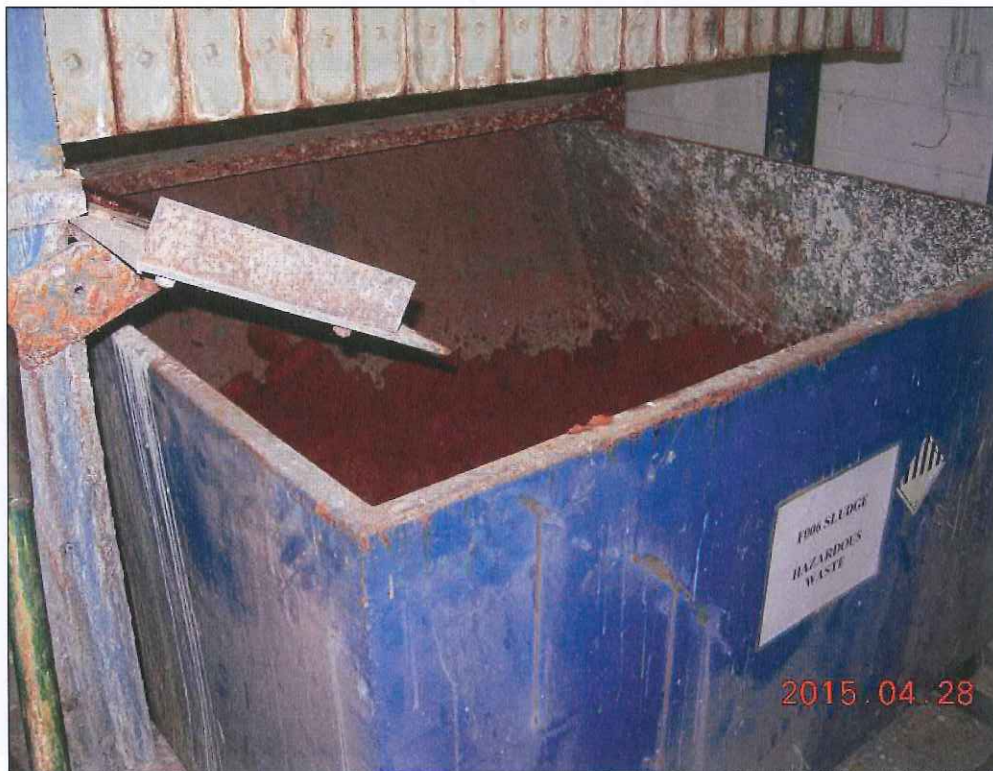
Picture #: 39
(DSCN1186)
Date: April 28, 2015
Photographer: Dan Chachakis
Location: Sludge press 1
Subject: Container

Sludge Presses, End of Wastewater Treatment System: I observed that there were two sludge presses in this area. I observed, and took a picture of, sludge press container 1 (Picture 39).

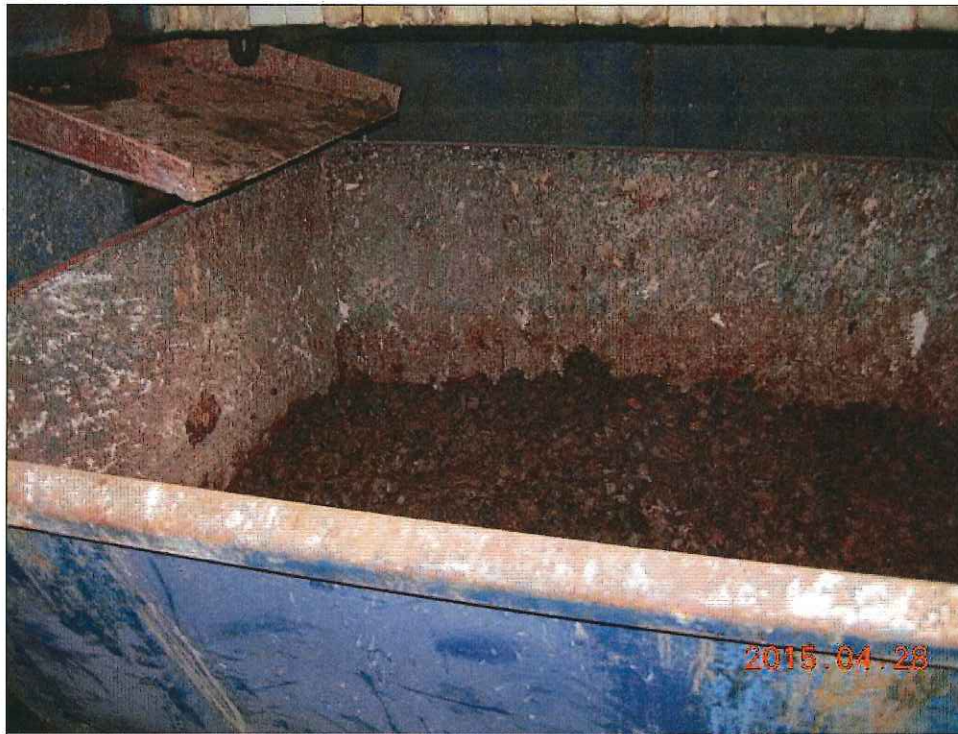
Picture #: 40
(DSCN1187)
Date: April 28, 2015
Photographer: Dan Chachakis
Location: Sludge press 2
Subject: Container

I observed, and took a picture of, sludge press container 2 (Picture 40).

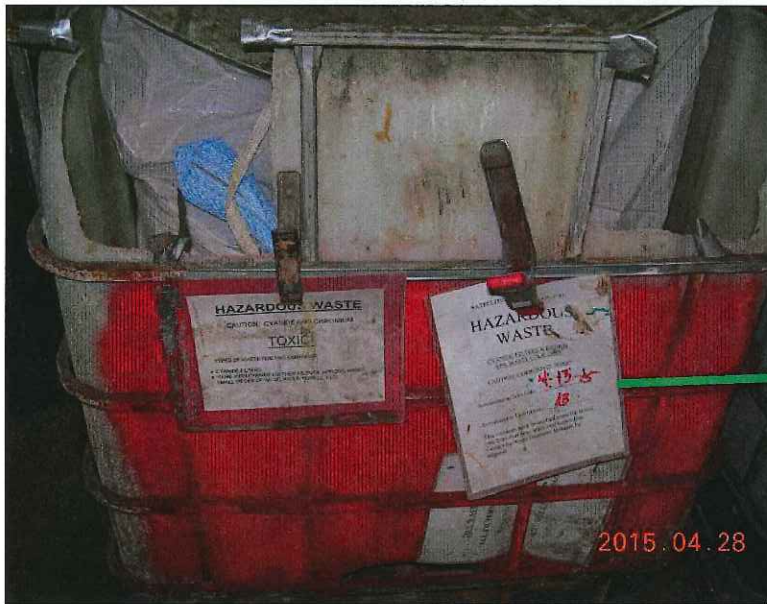
Picture #: 41
(DSCN1188)
Date: April 28, 2015
Photographer: Dan Chachakis
Location: Sludge press area
Subject: Container

I observed, and took a picture of, a container with a hazardous waste label, and words, "Caution: Cyanide and Chrome", the characteristic "D003", and an accumulation start date of "4/13/15" (Picture 41).

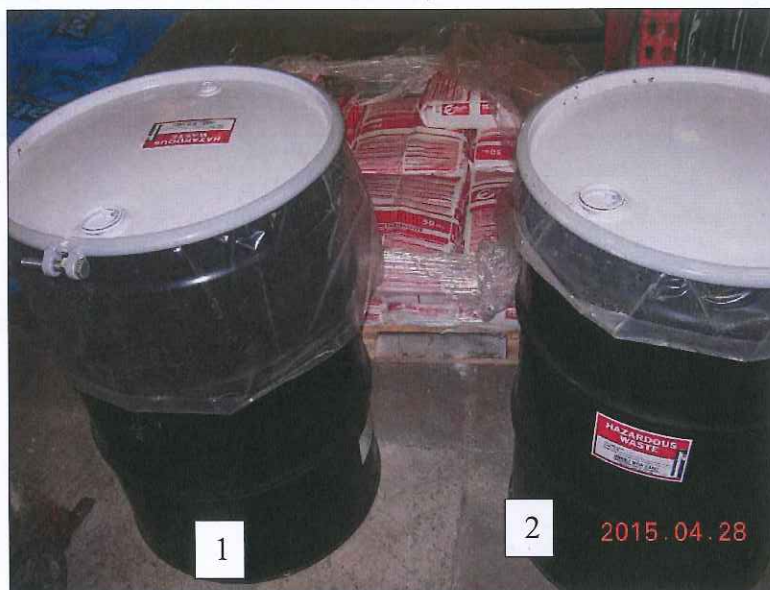
Picture #: 42
(DSCN1189)
Date: April 28, 2015
Photographer: Dan Chachakis
Location: Sludge press area
Subject: Two containers

I observed, recorded information from, and took a picture of two containers (Picture 42).

Contents of Containers in Picture 42			
#	Label	Accumulation Start Date	Contents on label
1	Hazardous Waste	4-19-15	Mag Phos Sludge
2	Hazardous Waste	4-16-15	Olive drab sludge

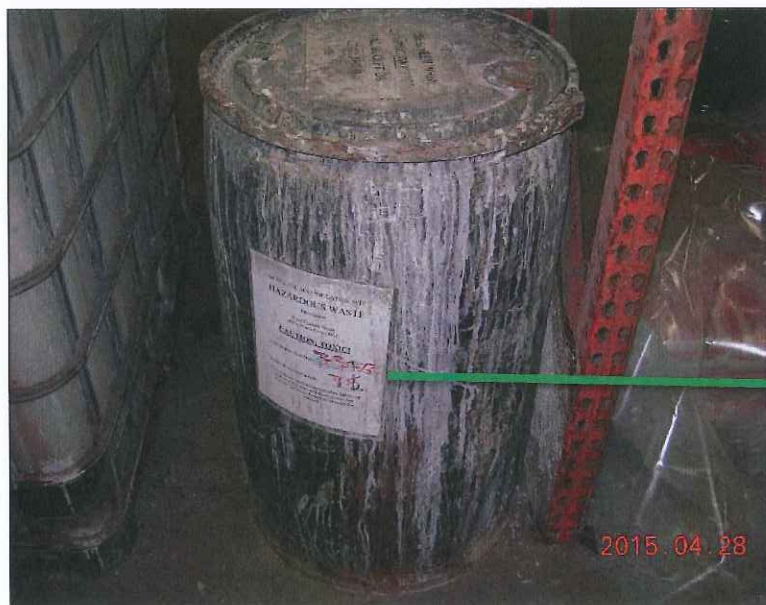
Picture #: 43
(DSCN1190)
Date: April 28, 2015
Photographer: Dan Chachakis
Location: Sludge press area
Subject: Container

I observed, and took a picture of, a container with a hazardous waste label marked with the words, "Used cyanide waste", the characteristic, "D003", and accumulation start date, "3-20-13" (Picture 43).

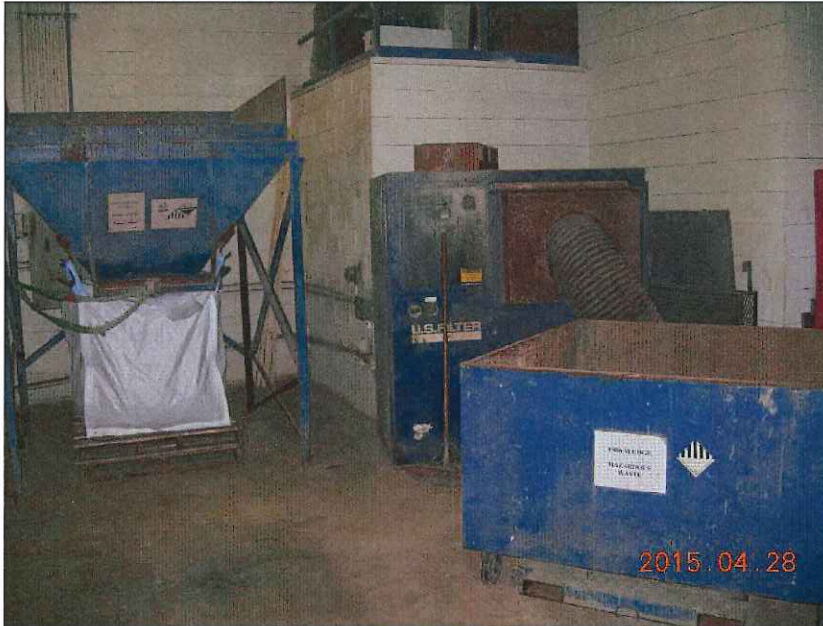
Picture #: 44
(DSCN1191)
Date: April 28, 2015
Photographer: Dan Chachakis
Location: Sludge Packing Area
Subject: Tote and empty container

Sludge Packing Area: I observed, and took a picture of, the sludge packing area (Picture 44). Mr. Madden stated this area is where sludge from the containers in Pictures 39 and 40 is transferred to totes. He stated that the containers are lifted by forklift. I observed that the bag in place does not have a hazardous waste label or accumulation start date.

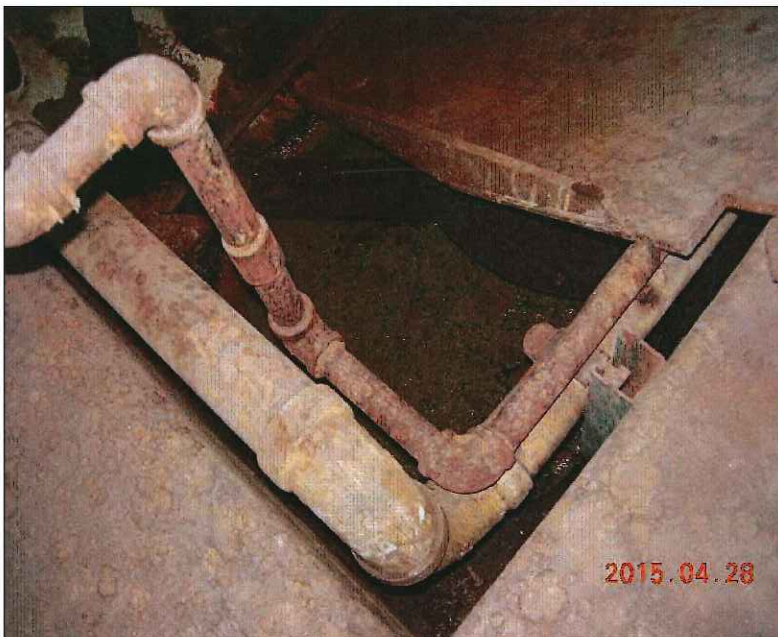
Picture #: 45
(DSCN1192)
Date: April 28, 2015
Photographer: Dan Chachakis
Location: Chromatic Line
Subject: Sump

Chromatic Line: I observed, and took a picture of, a sump that was full of liquid (Picture 45).
